An Taisce
The National Trust for Ireland

Buildings at Risk

November 2014

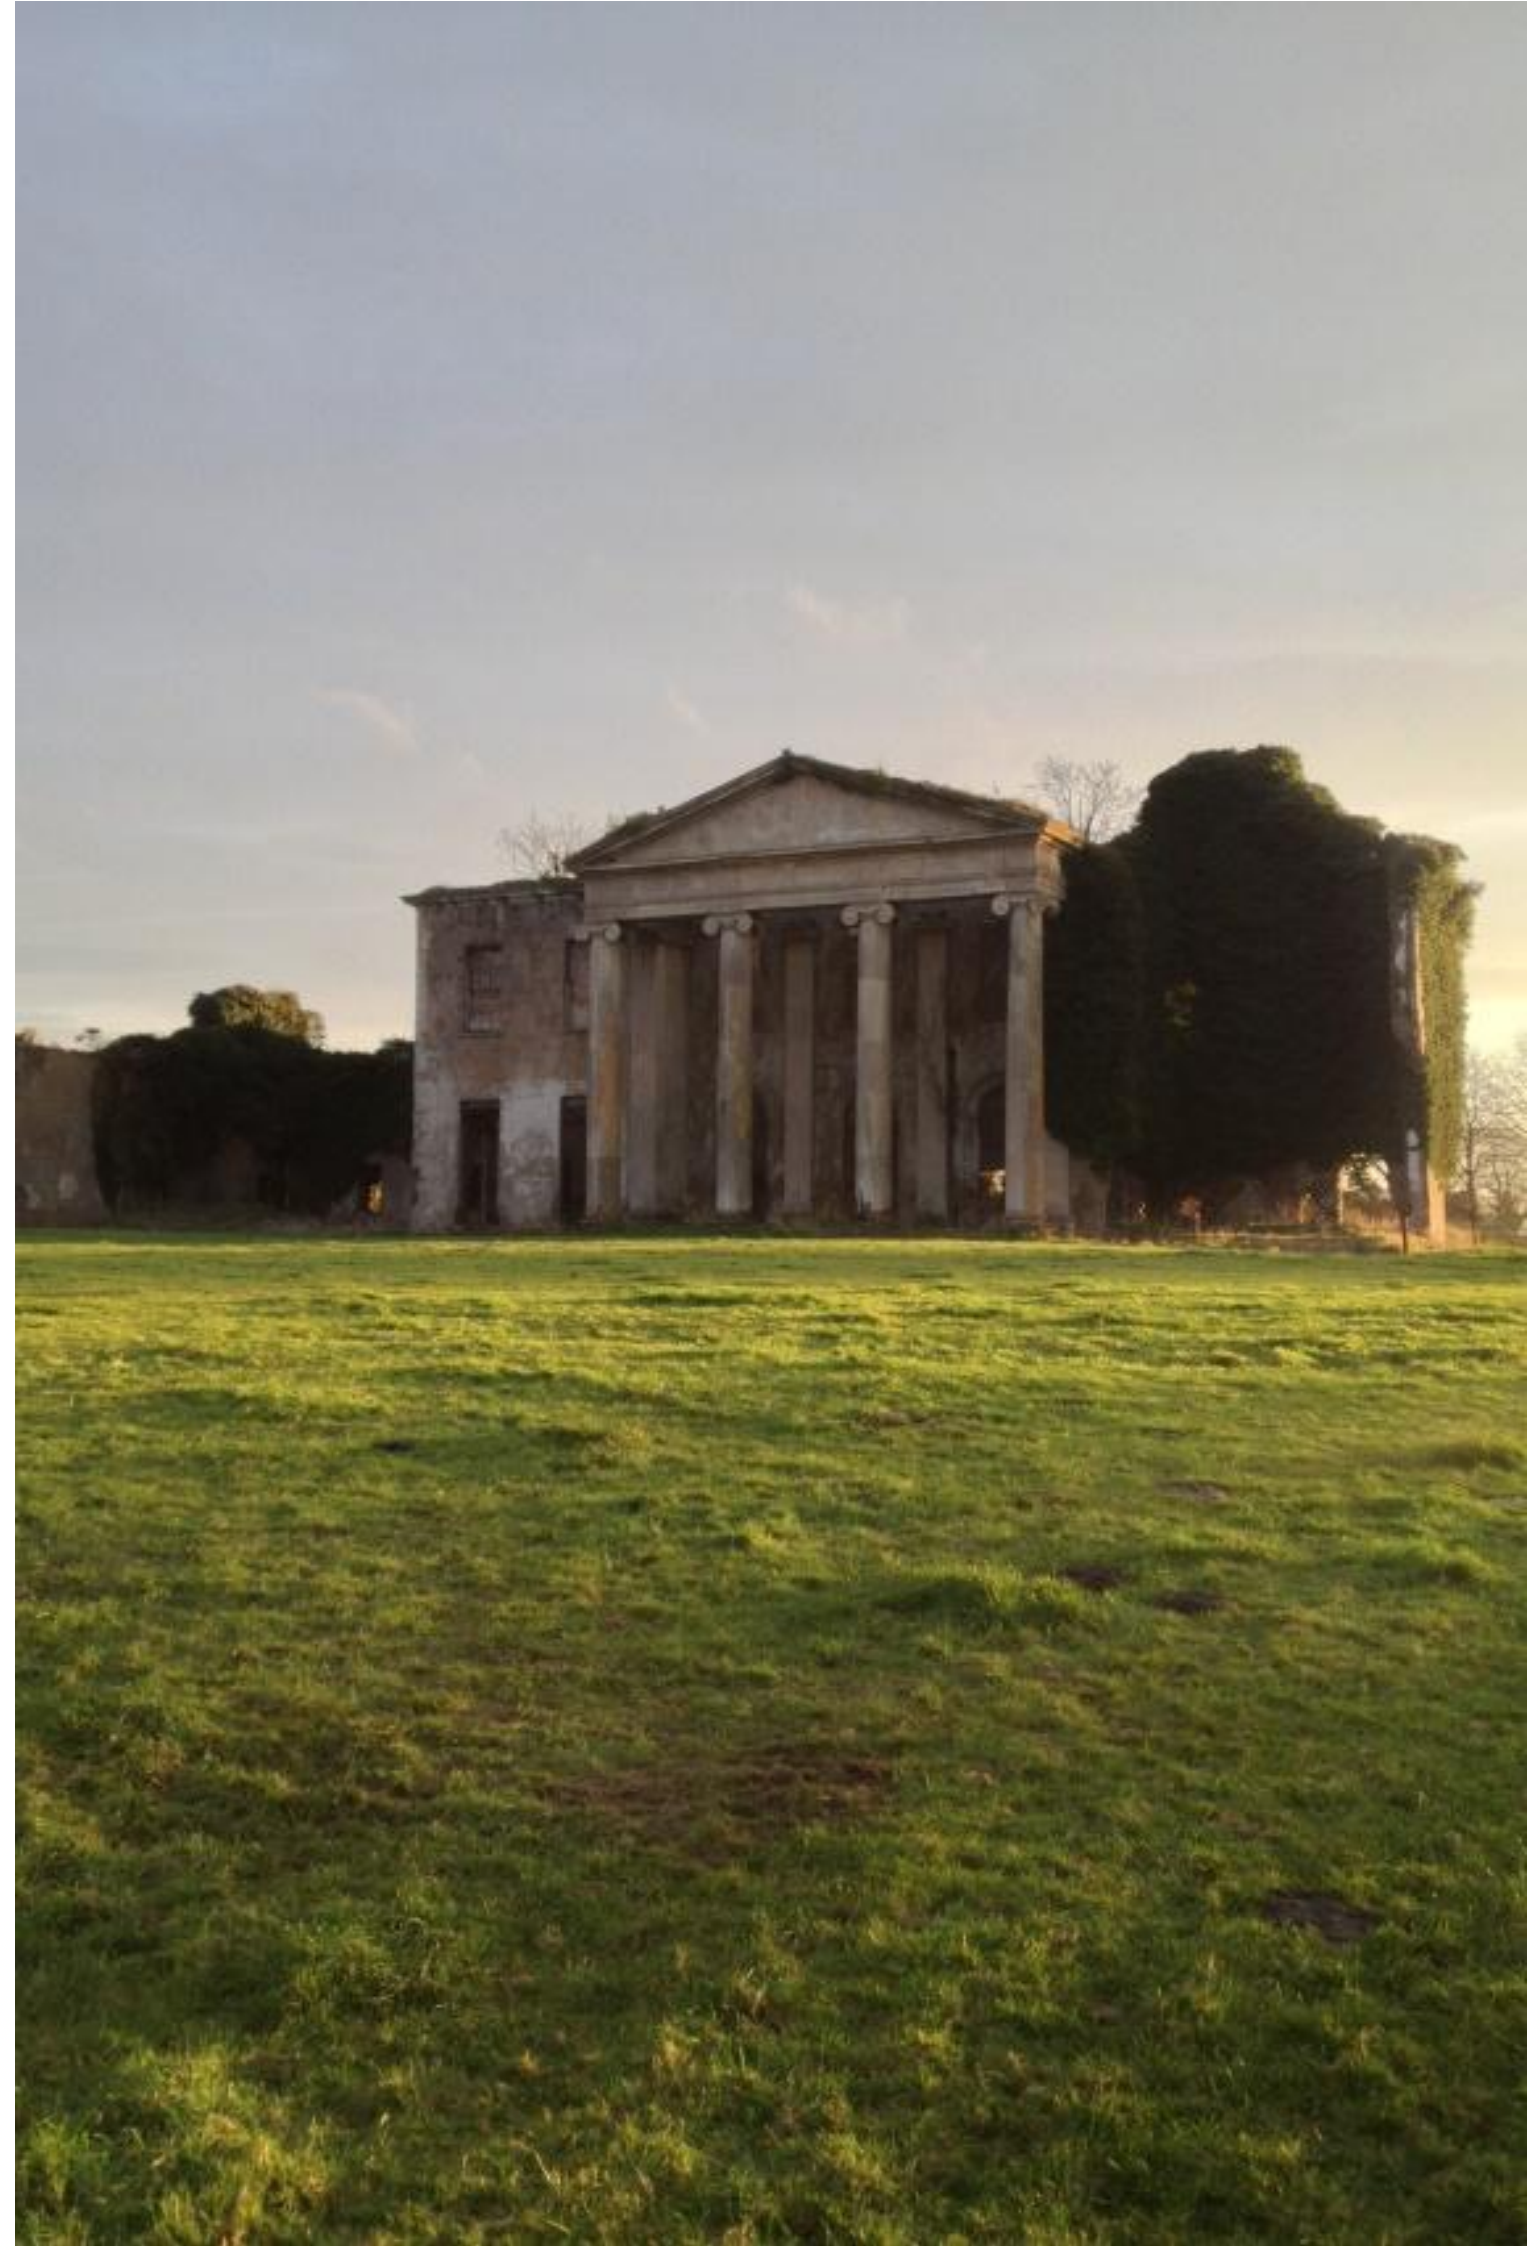
Dromore Castle

A dramatically sited ruin of mid 19th century castle built to design of EW Godwin for the 3rd Earl of Limerick. Godwin researched medieval Irish buildings and included a round tower to evoke the silhouette of the Rock of Cashel. The residential use ceased during World War I and the building became derofed in 1950s. A number of restoration proposals have not proceeded. The structure is of significant historic importance and requires conservation works to prevent further deterioration.

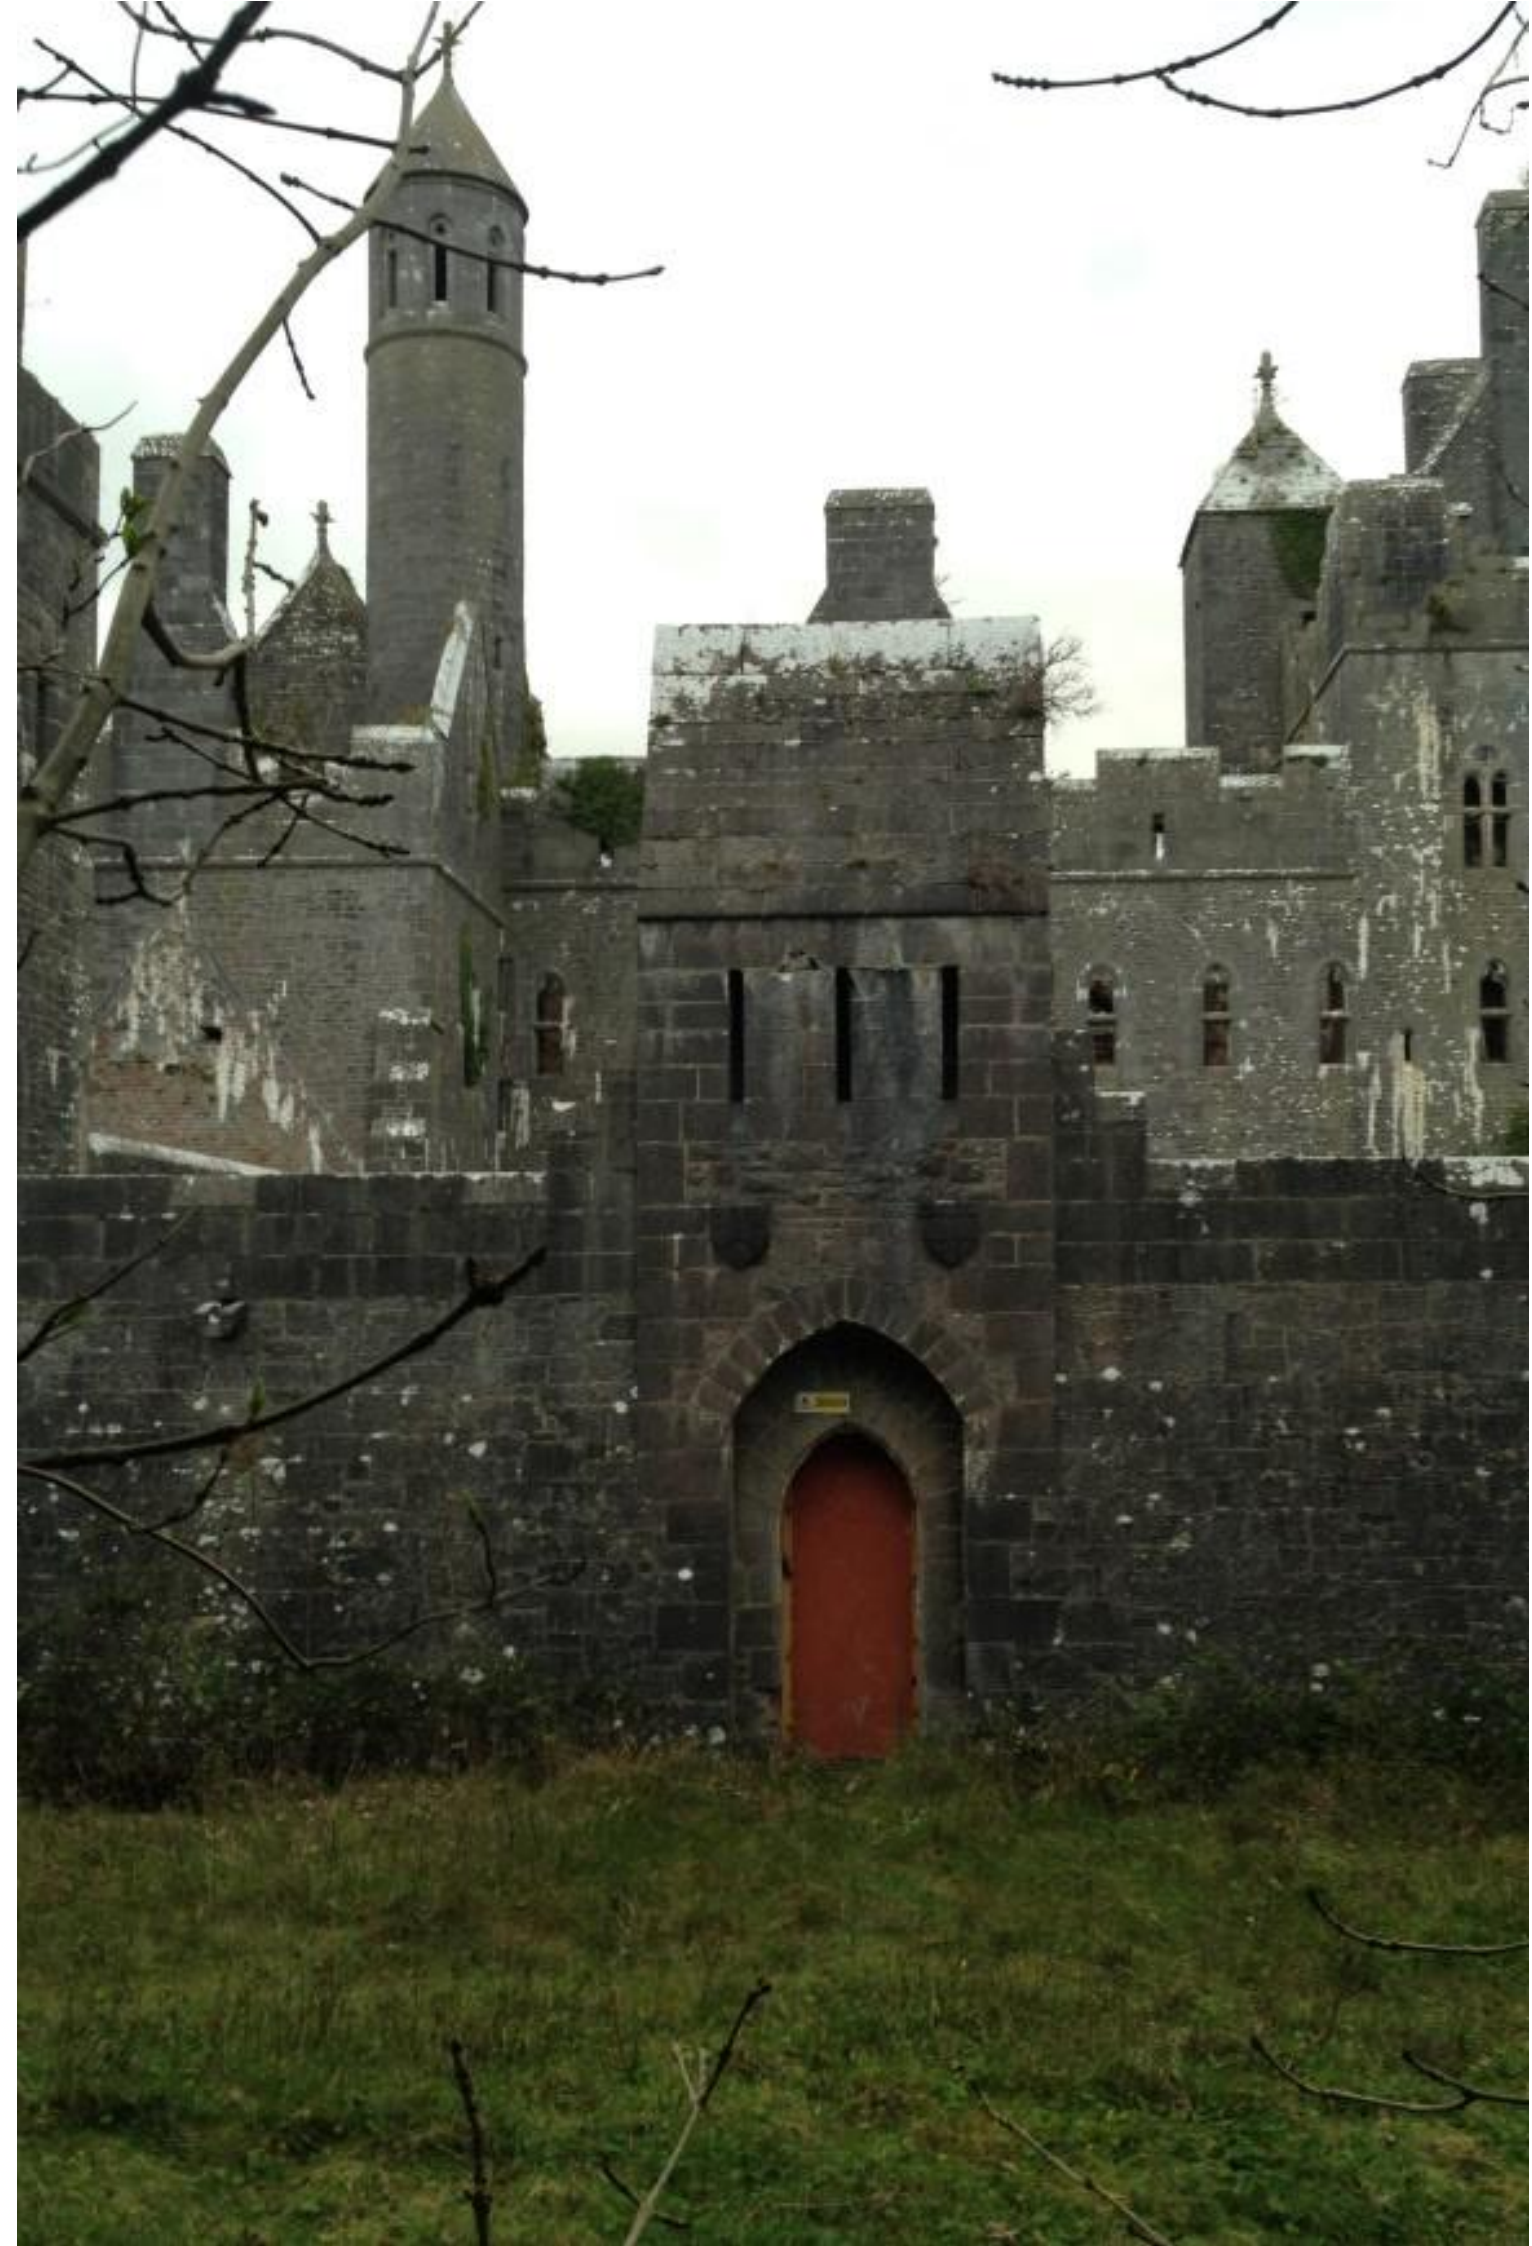
Bannatyne Mill is a detached eight-bay, five-storey limestone former corn store, built circa 1874. A very imposing and rare structure, it is technically important due to the fact its frame is made of cast iron. The high degree of detailing on this industrial building is extraordinary when compared with modern industrial buildings, which are almost always devoid of ornamentation. This building urgently requires new uses to be identified to prevent further deterioration of its character.

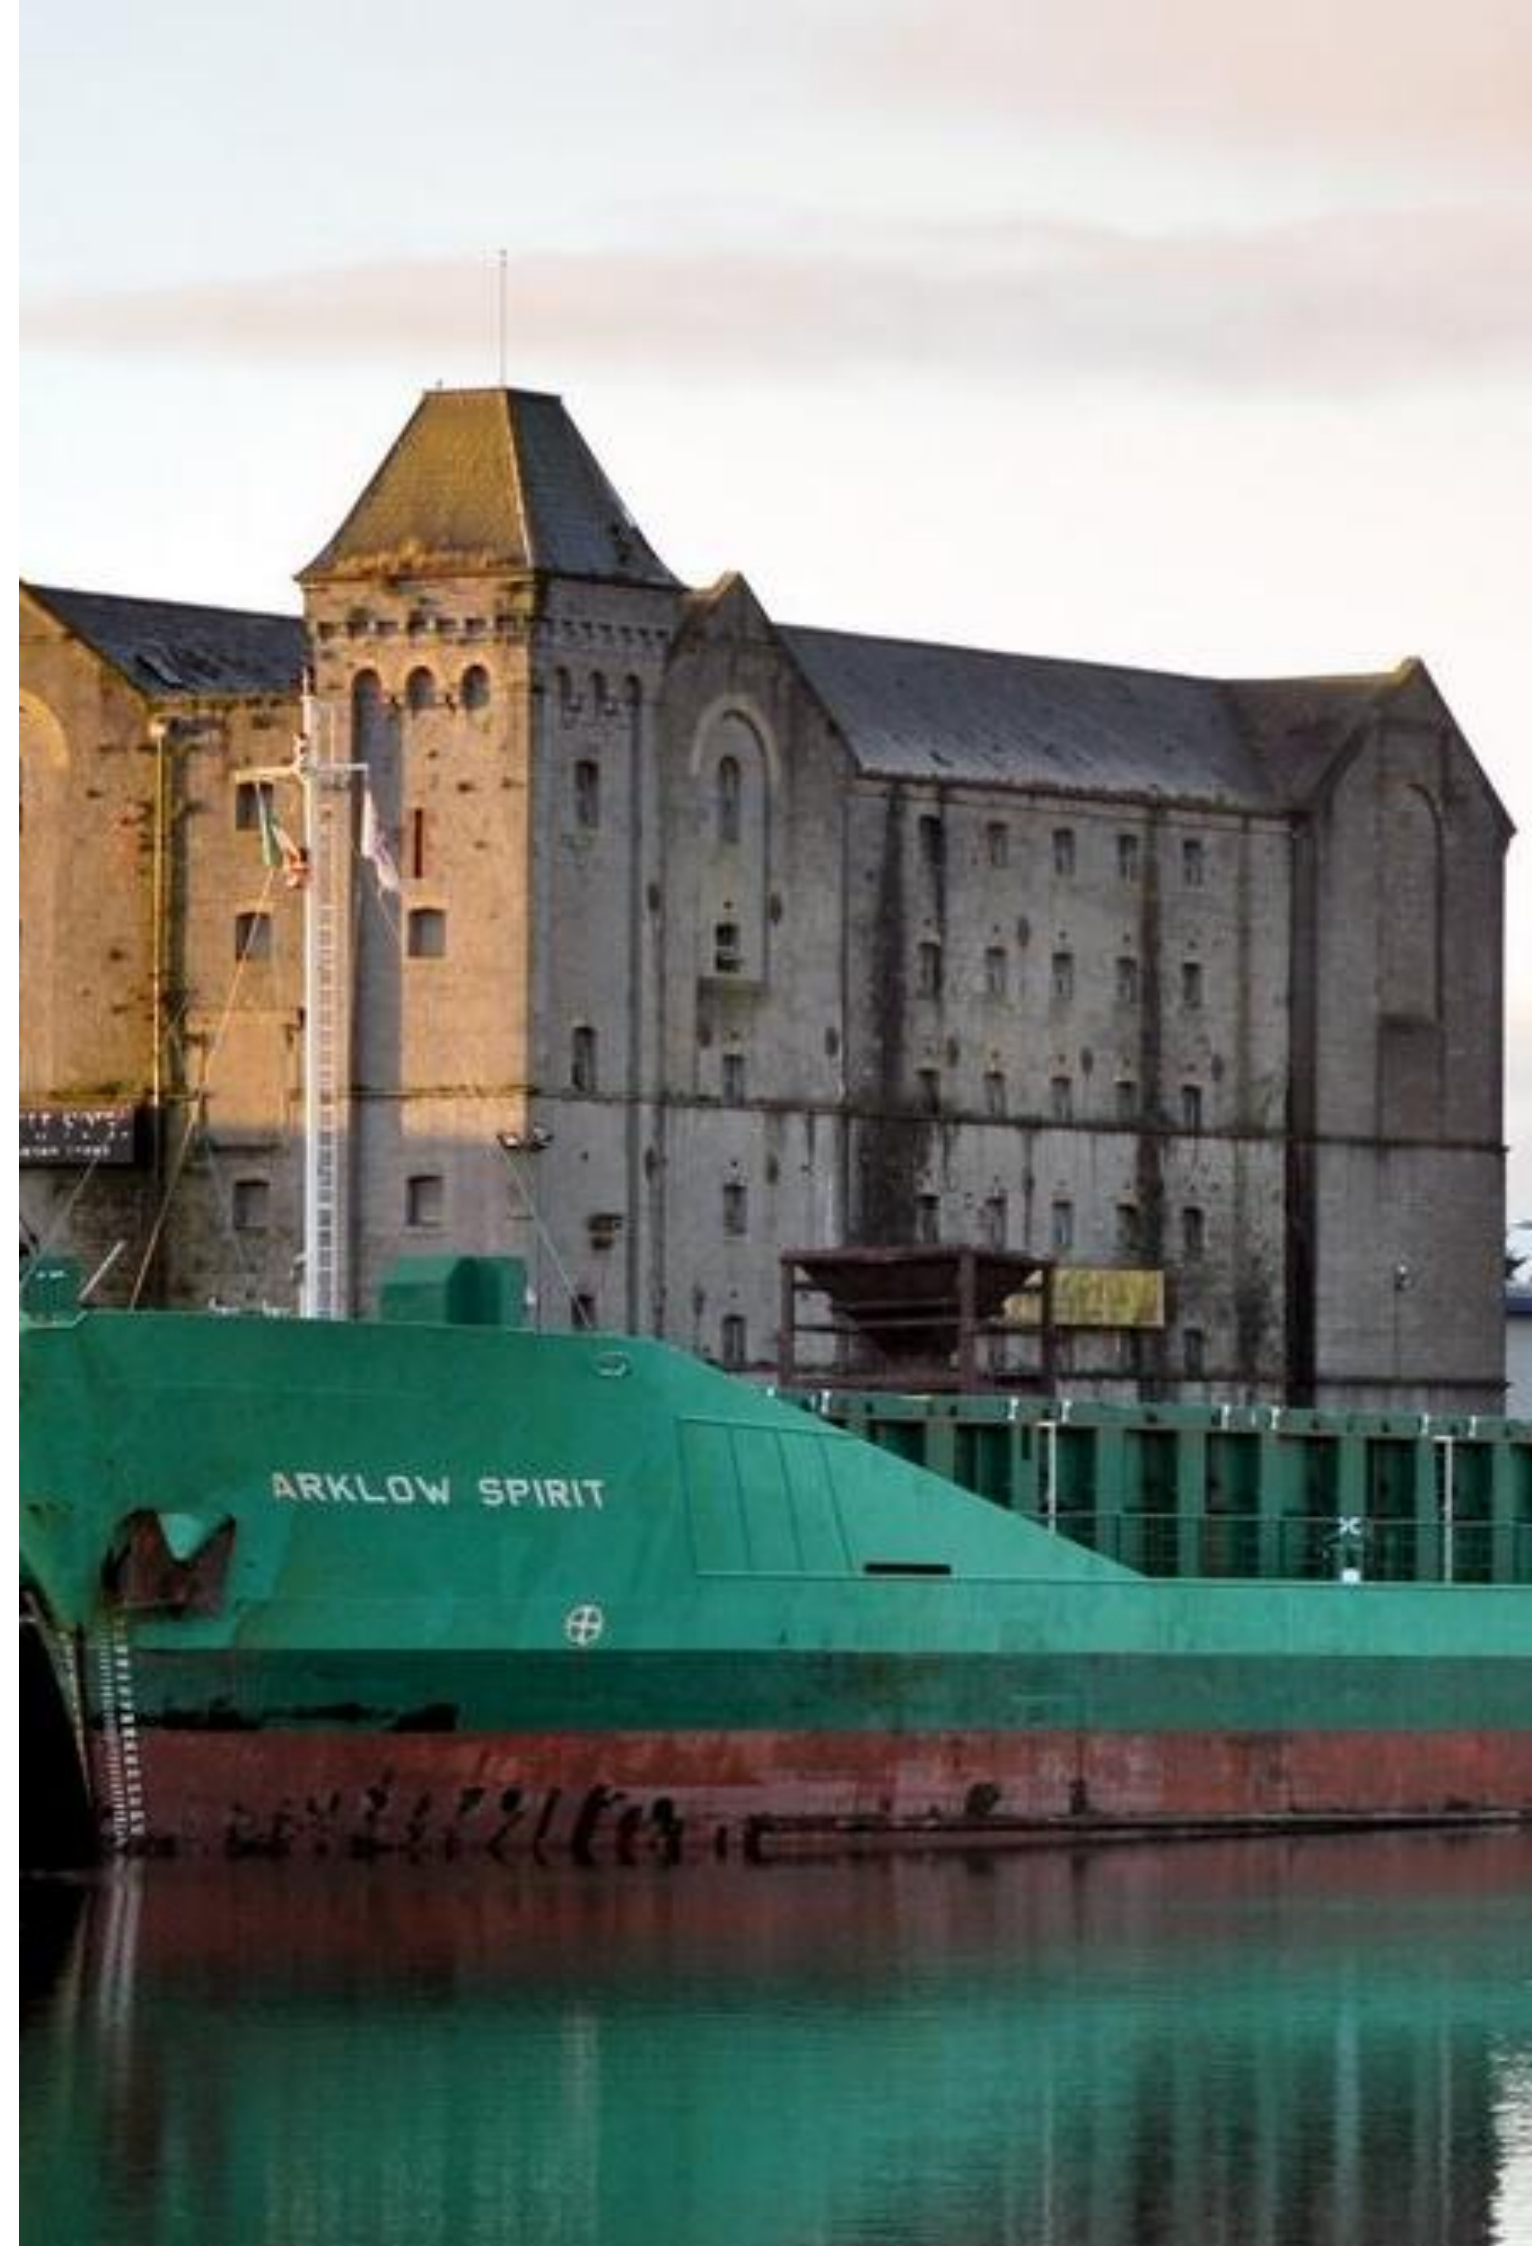
Curry Lane House

What remains on Curry Lane is a ruin of a substantial late medieval building reflecting the historical development of Limerick. It requires appropriate conservation and incorporation into future development

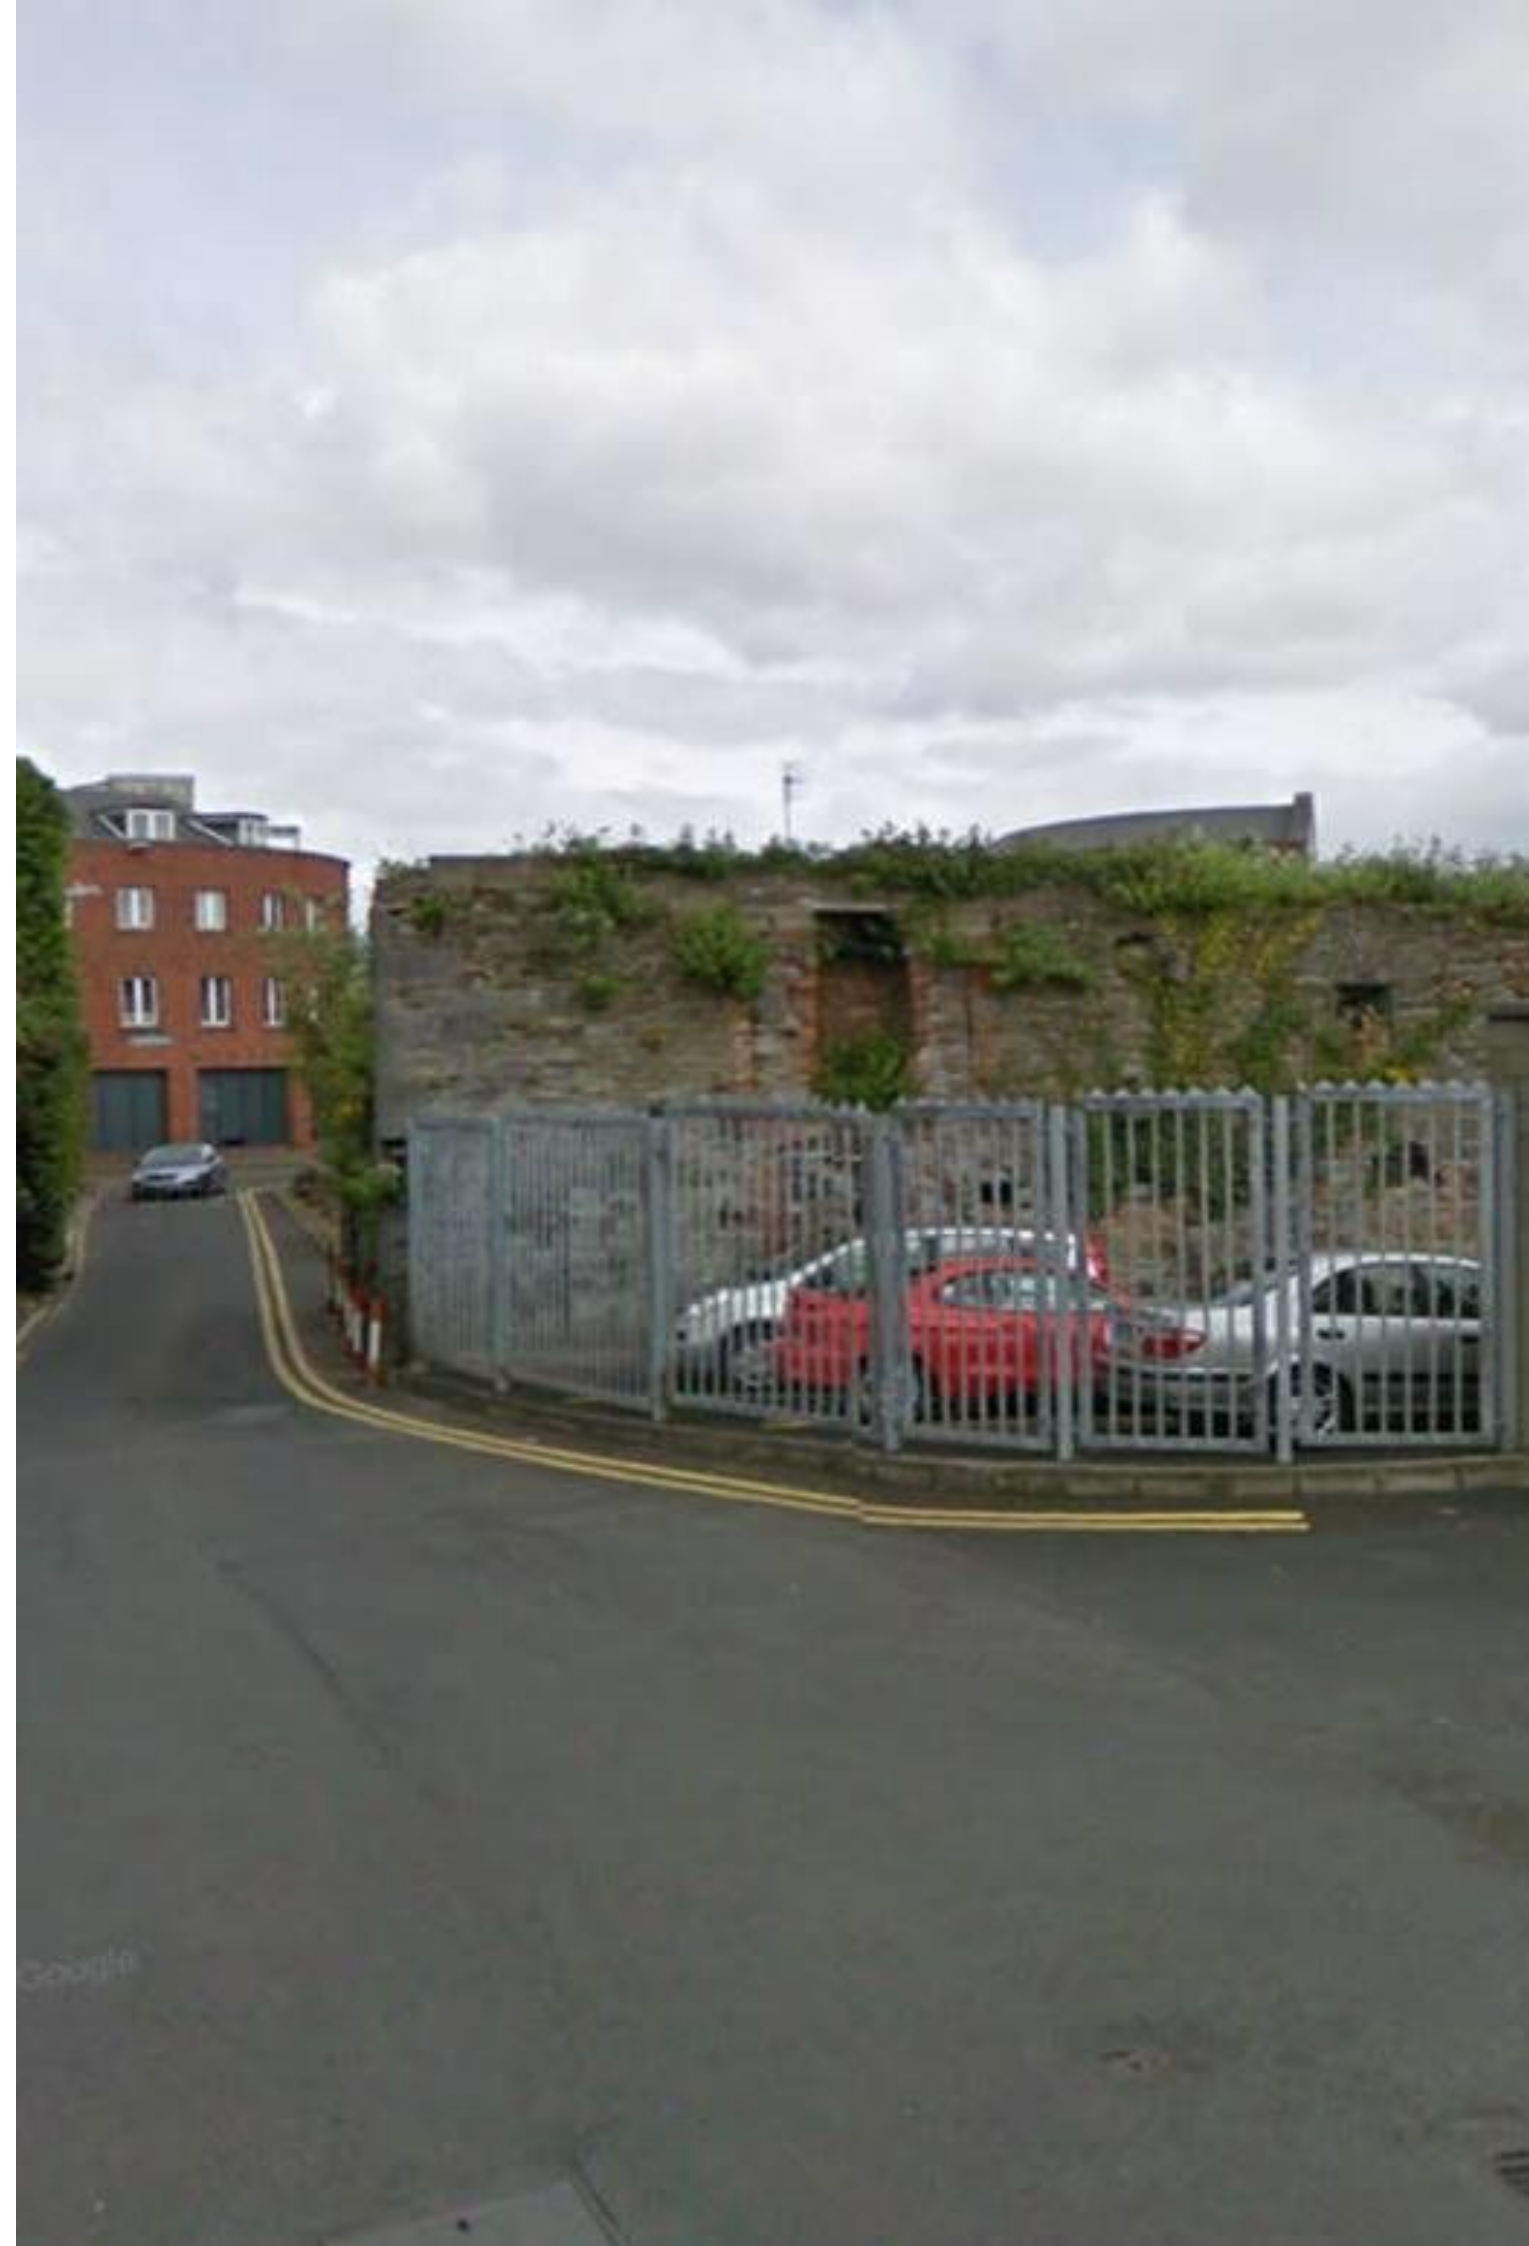
General Post Office

The building is currently waiting redevelopment to commercial use as part of a larger mix-use scheme. However, this scheme has stalled and the building is now vacant. The windows have been removed. Even if an appropriate use for the building is found, its setting has been compromised by the high rise office tower behind. As the former General Post Office, this building has played an important role in the history of the city. It is also one of the few remaining historic structures on this part of Henry Street. As such, it has huge heritage value to the city, and it should be brought back into active use as soon as possible to be identified to prevent further deterioration of its character.

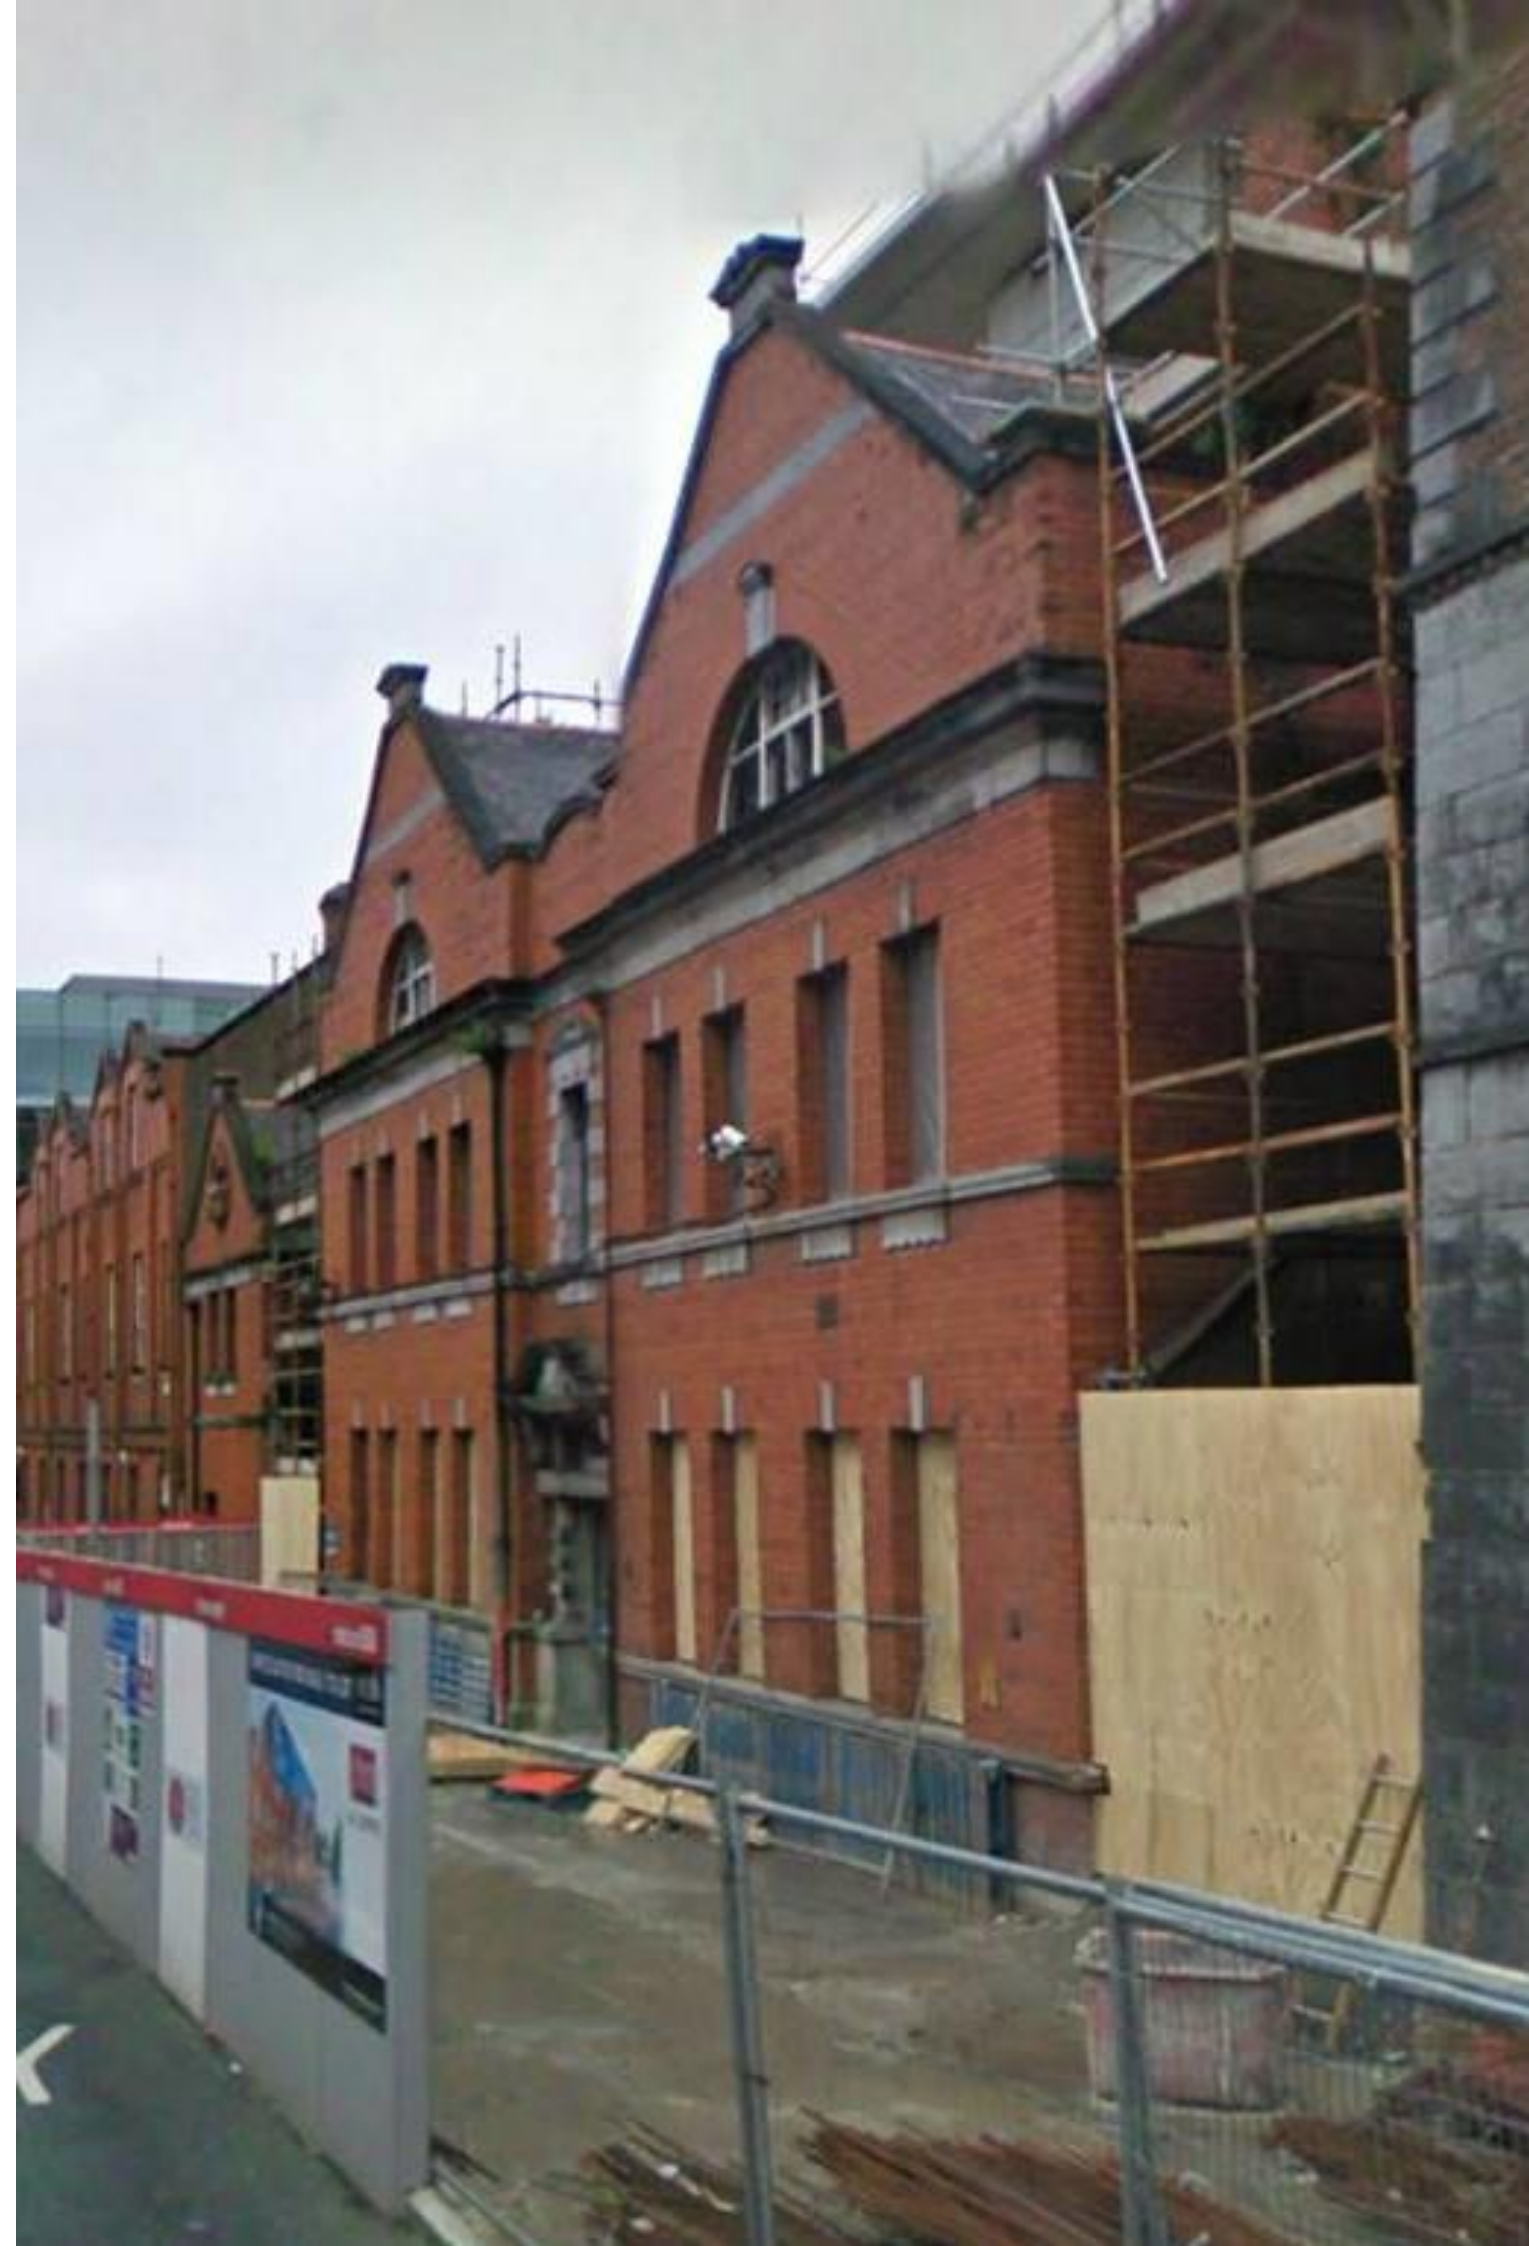
Mulgrave St Magazine

The Mulgrave Street Magazine is an early 19th century gunpowder store forming part of the barracks complex. While of robust vaulted construction, the building is poorly maintained. It is identified in the National Inventory as a rare survival of its kind. The structure is of significant historic importance and requires conservation works to prevent further deterioration.

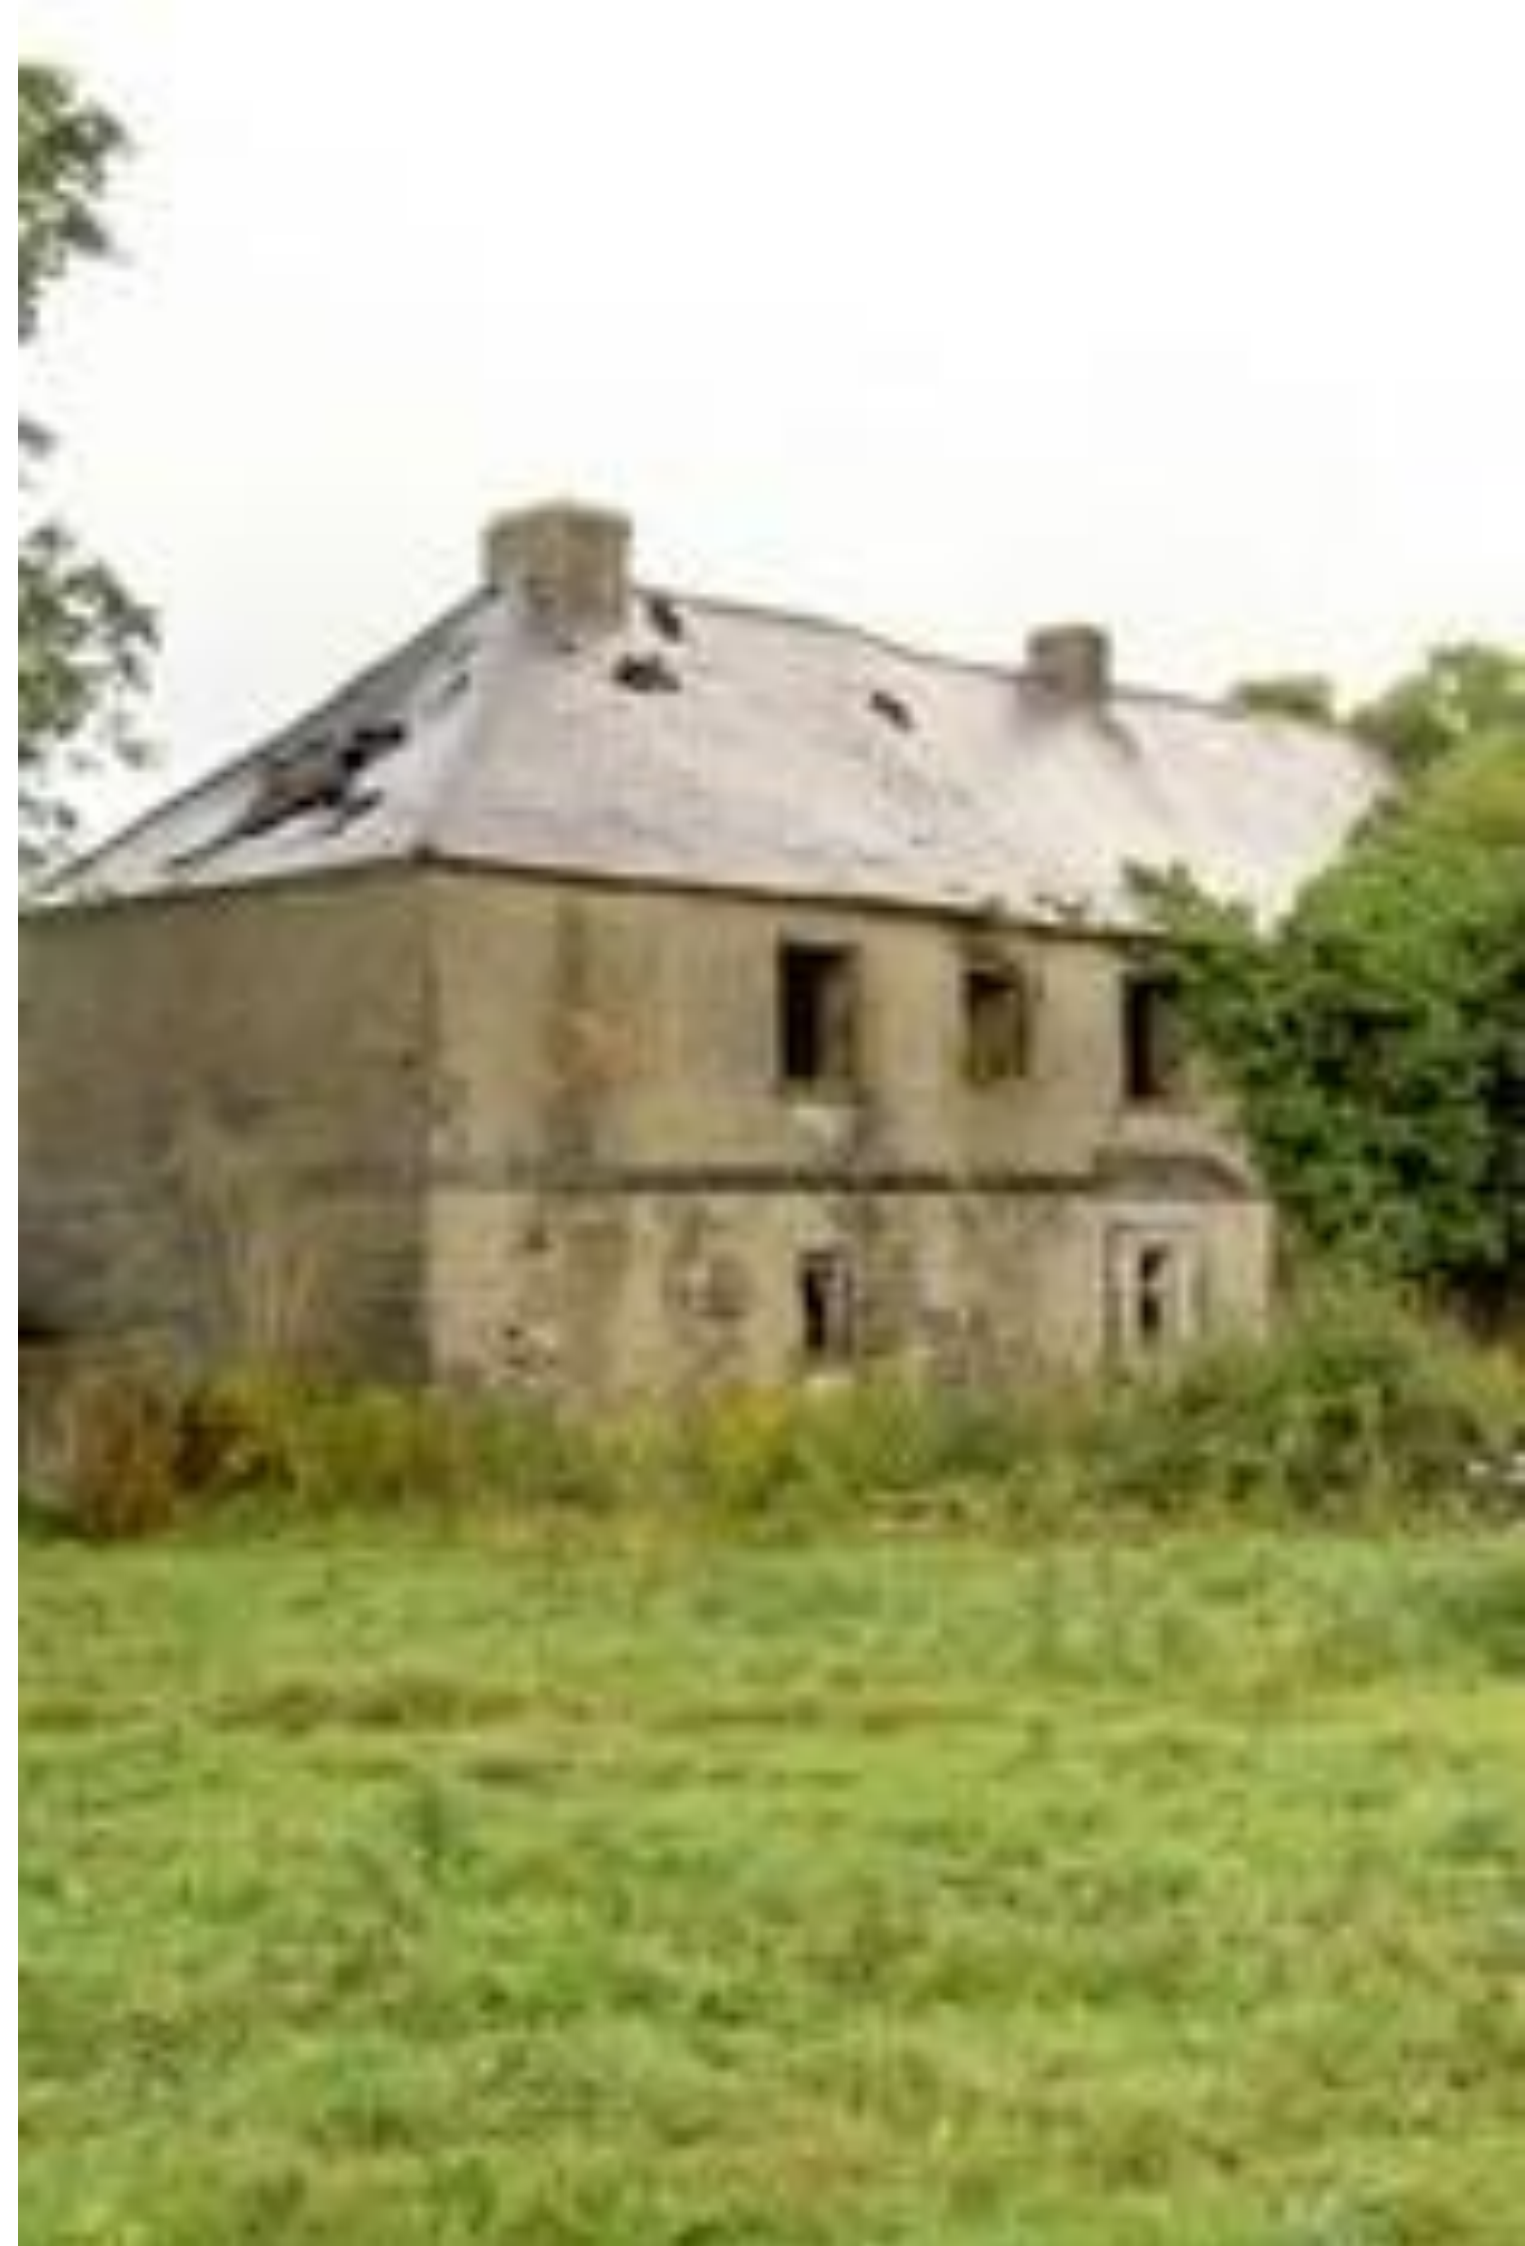
Carrigglas Manor

Vacant with no identified new use	X
Suffering from neglect and/or poor maintenance	X
Suffering from structural problems	
Fire damaged	
Threatened with demolition	
Ruin which is poorly maintained

Condition of Structure	Poor
Level of Risk	High

This building has been vacant for a number of years and does not appear to be maintained. Most of the external fabric remains, but there are obvious signs of deterioration, particularly water penetration, slipped slates and vegetation growth. There is no immediate danger of collapse but the condition is such that unless urgent remedial works are carried out the building will sharply deteriorate.

Carriglass is an early 19th century Tudor revival house designed by Daniel Robertson and formerly the residence of the Lefroy Family. The late 18th century stable yard and main entrance gates are designed by James Gandon. There have been major residential developments proposed on the site in the past decade, however, it has largely stalled with only the first phase of housing having been constructed on the grounds. The use of main house and stables remains unresolved. According to a local newspaper the estate was sold to the Glennon Brothers in June 2014. This building urgently requires new uses to be identified to prevent further deterioration of its character.
